DORAL MINERAL SANDS PTY LTD (DORAL)

KEYSBROOK MINERAL SANDS PROJECT

COMPLIANCE ASSESSMENT REPORT – AUDIT TABLE

Dated: 18 October 2023

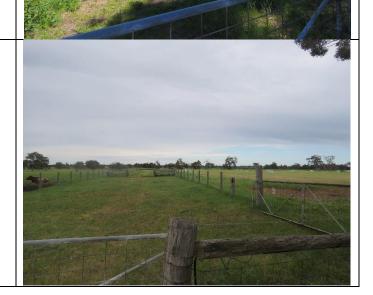
4th October 2018

Mining Activities Visible:

- Perimeter bunds
- MFU
- Mobile plant
- Some distant views of earthworks, predominantly noise/visual earthen bunds.

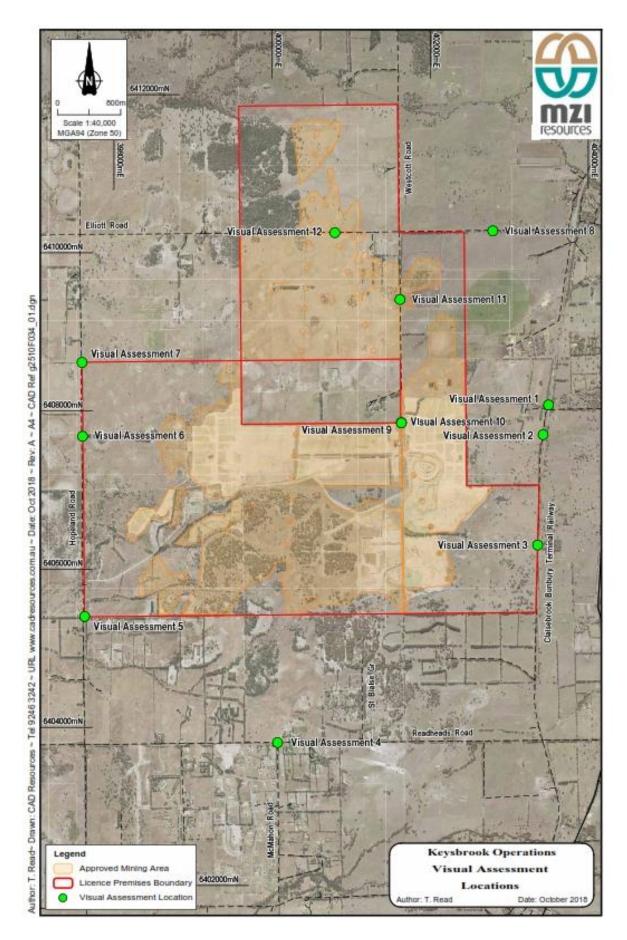
| Coordinates: | MGA94 Zone 50 | 400793mE | 6410255mN |
|---|---|---|---|
| 13 th October 2023 <u>Mining Activities Visible</u> : | | | |

| Coordinates: | MGA94 Zone 50 | 400793mE | 6410255mN |
|---|---|---|---|
| Noise Bund Mining activit Dust Crops | | | |
