2023 Compliance Assessment Report Yoongarillup Mineral Sands Project

Ministerial Statement 1030

6th September 2023

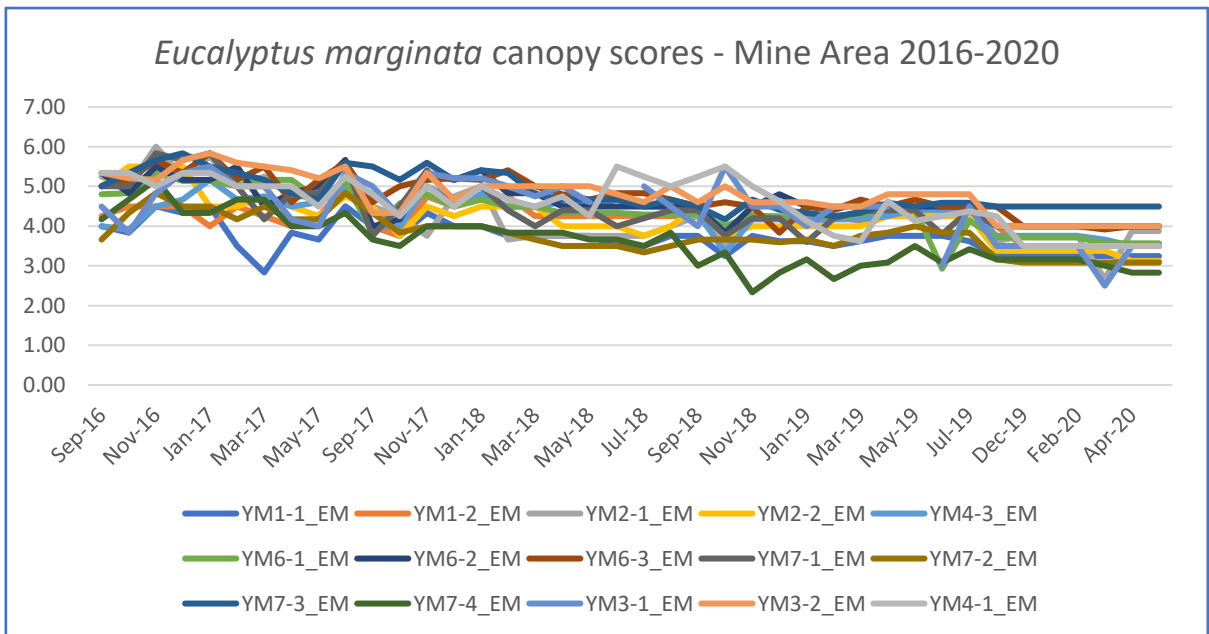
There is a general downward progression of canopy density scores (CD score) in *Eucalyptus marginata* over the monitoring period (2016-2020). This decline is apparent in both the Mine Area (YM) sites (**Figure 6**) and the Reference (YR) sites (**Figure 7**). At the YM sites the mean score in September 2016 was 4.7 – this had declined to 3.6 in May 2020. At the YR sites the mean CD declined from 4.8 to 3.8. Hence there was a similar level of decline in canopy scores at both YM sites and YR sites and the cause was likely declining rainfall rather than mining activities.

Figure 6. Canopy Density in *Eucalyptus marginata* at the Mine Area (YM) sites during the 2016-2020 period

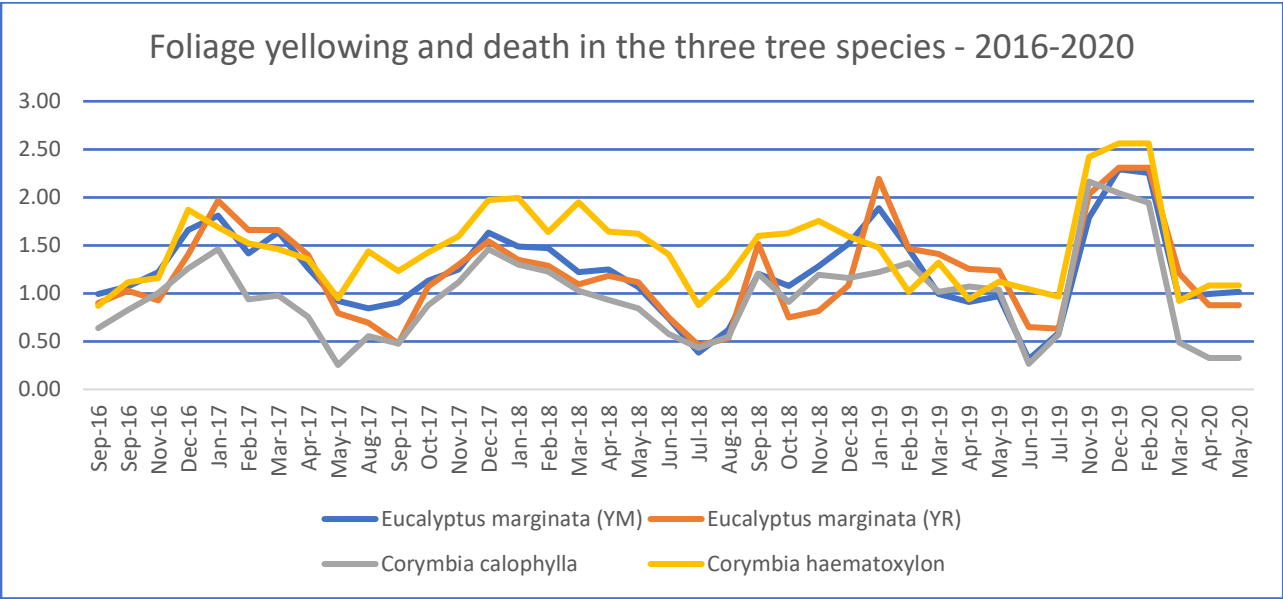
Of the three tree species *C. haematoxylon* displayed the greatest amount of foliage yellowing and death over the four years (Figure 14), while *C. calophylla*, as would be expected from its downslope habitat had the lowest.

Figure 14. Mean values for foliage yellowing and death in the three tree species at Yoongarillup over the period 2016-2020.

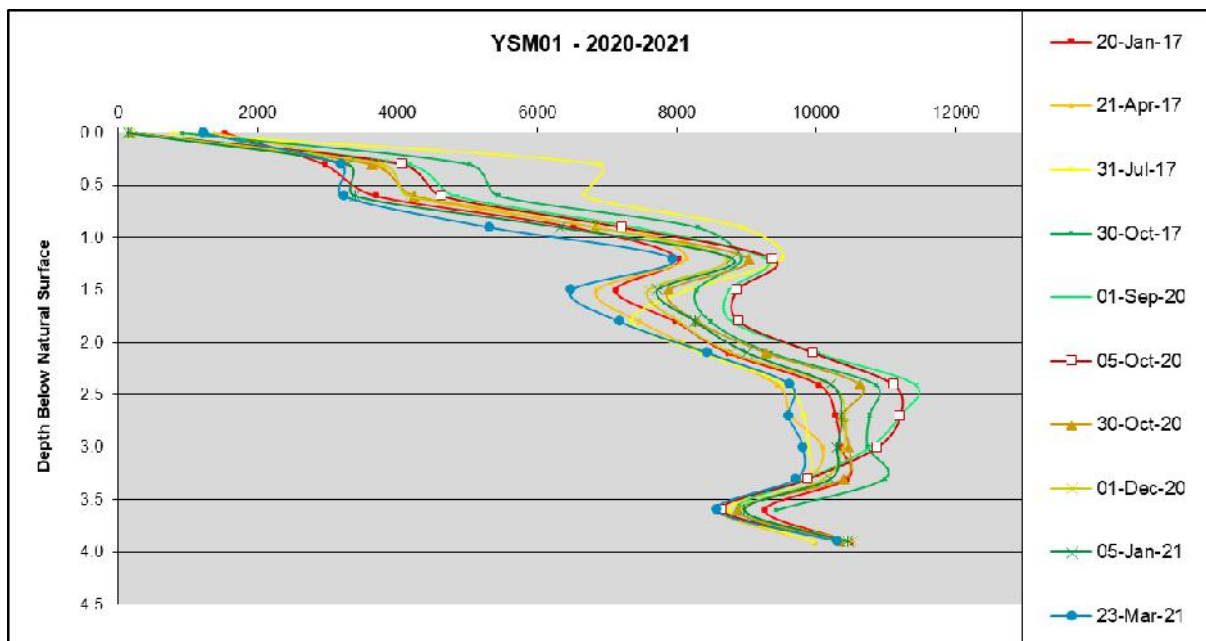
From the soil moisture profile shown in Figure 4 below, the effects of 18 rainy days received over September 2020 can be seen throughout most of the profile with moderate to high moisture levels observed in September and early October. The entire profile became progressively drier from late October 2020 with the greatest reduction observed in the top metre and the driest moistures were recorded in January 2021 and March 2021 deeper in the profile. This is expected as per seasonal fluctuations and is relative to the 2017 background profiles prior to autumn rains.

Figure 4 Soil Moisture YSM01 (including 2017 background profiles)

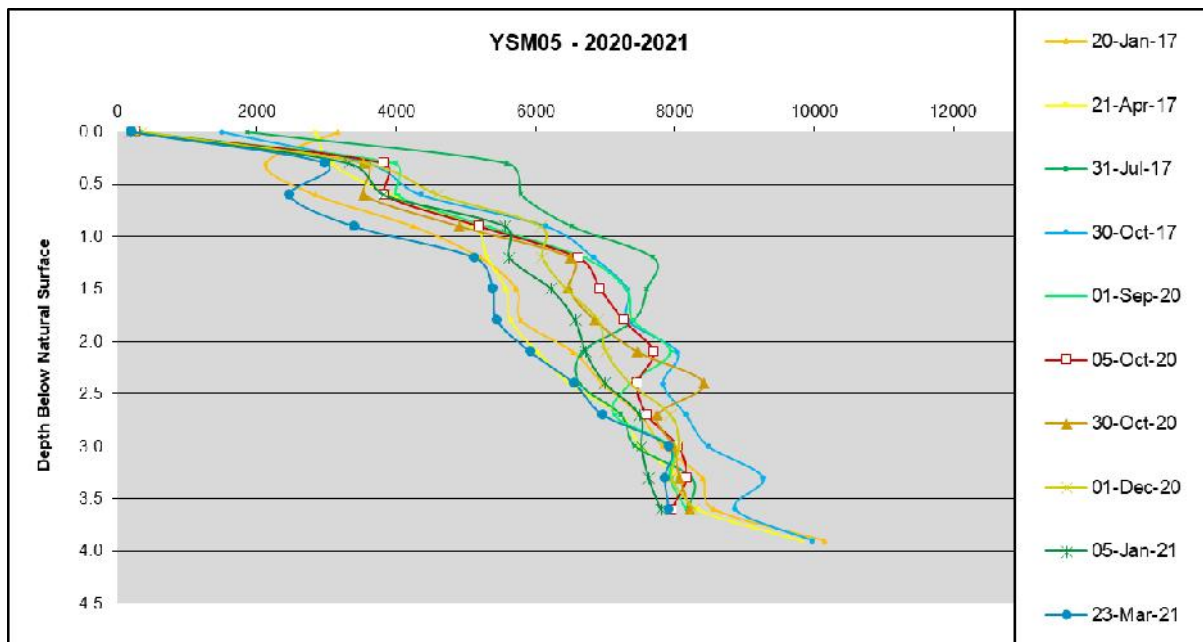
The soil moisture profiles shown in Figure 8 show a lower moisture profile for March 2021 as expected with no rainfall being received for December 2020 and January 2021. The March 2021 profile is not too dissimilar to pre mining profiles for the same period which is a reflection of seasonal variation.

Figure 8 Soil Moisture YSM05 (including 2017 background profiles)

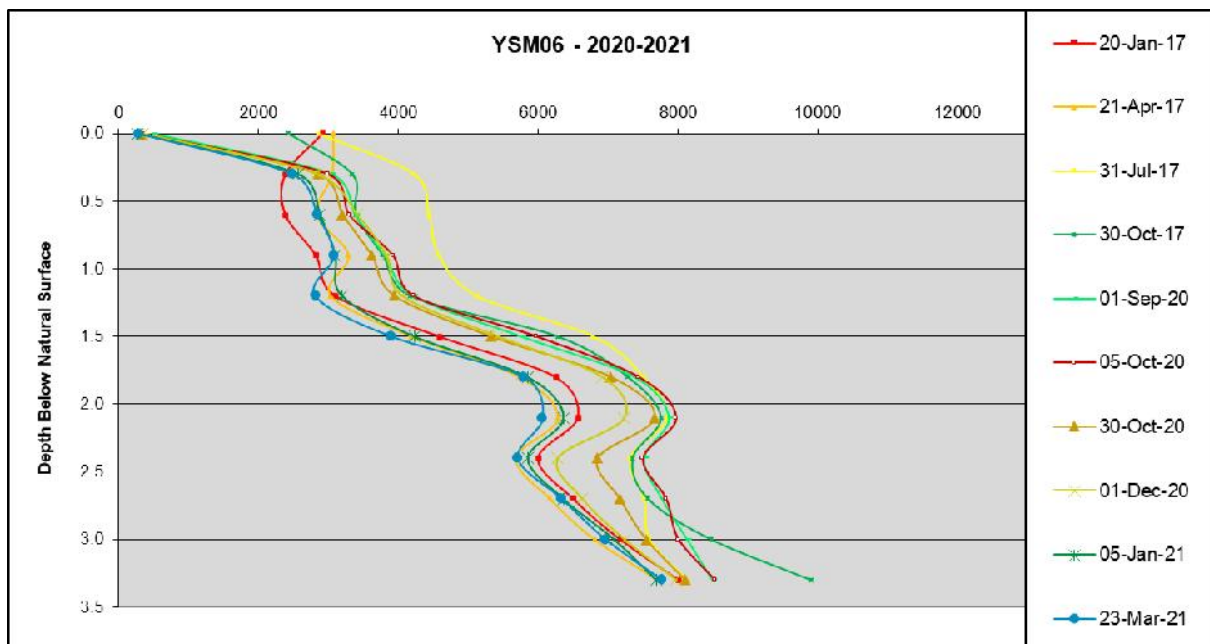
The soil moisture profile shown below (Figure 9) is consistent with historical seasonal fluctuation and March 2021 reflects the lack of rainfall received in December 2020 and January 2021. The site did receive above average rainfall in May 2021.

Figure 9 Soil Moisture YSM06 (including 2017 background profiles)

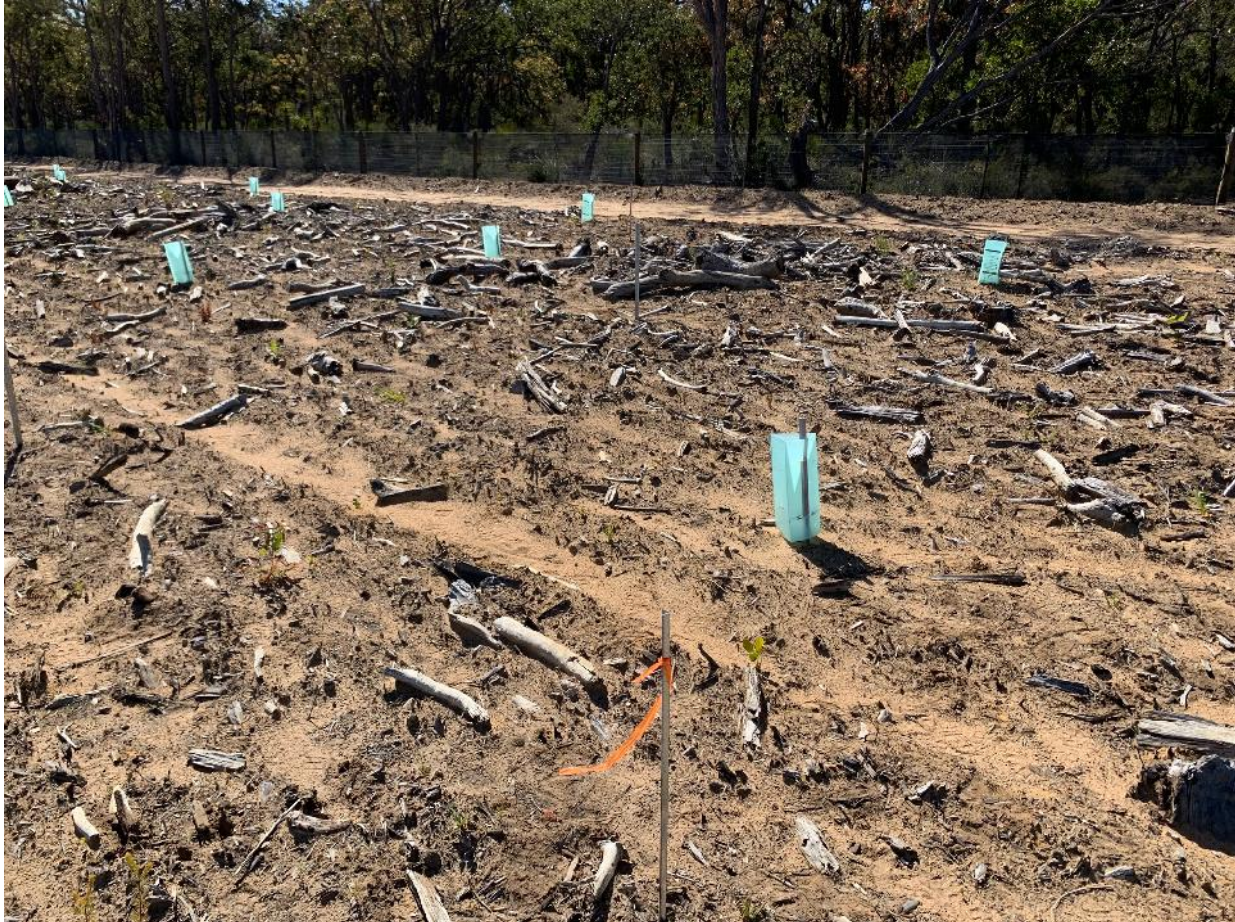
Figure 5: Quadrat 1 Photo - Late Spring Monitoring Event November 27th 2020

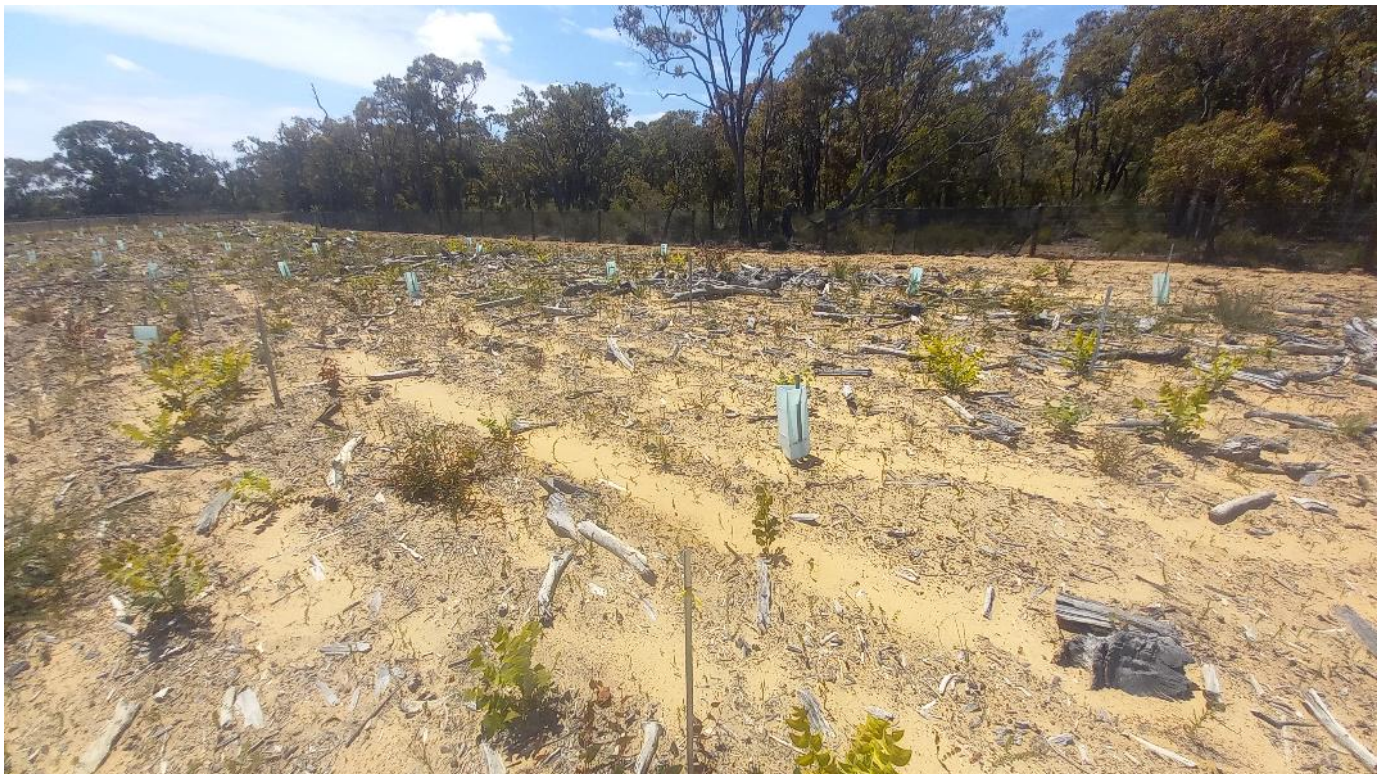
Figure 6: Quadrat 1 Photo - Late Spring Monitoring Event November 23rd 2021

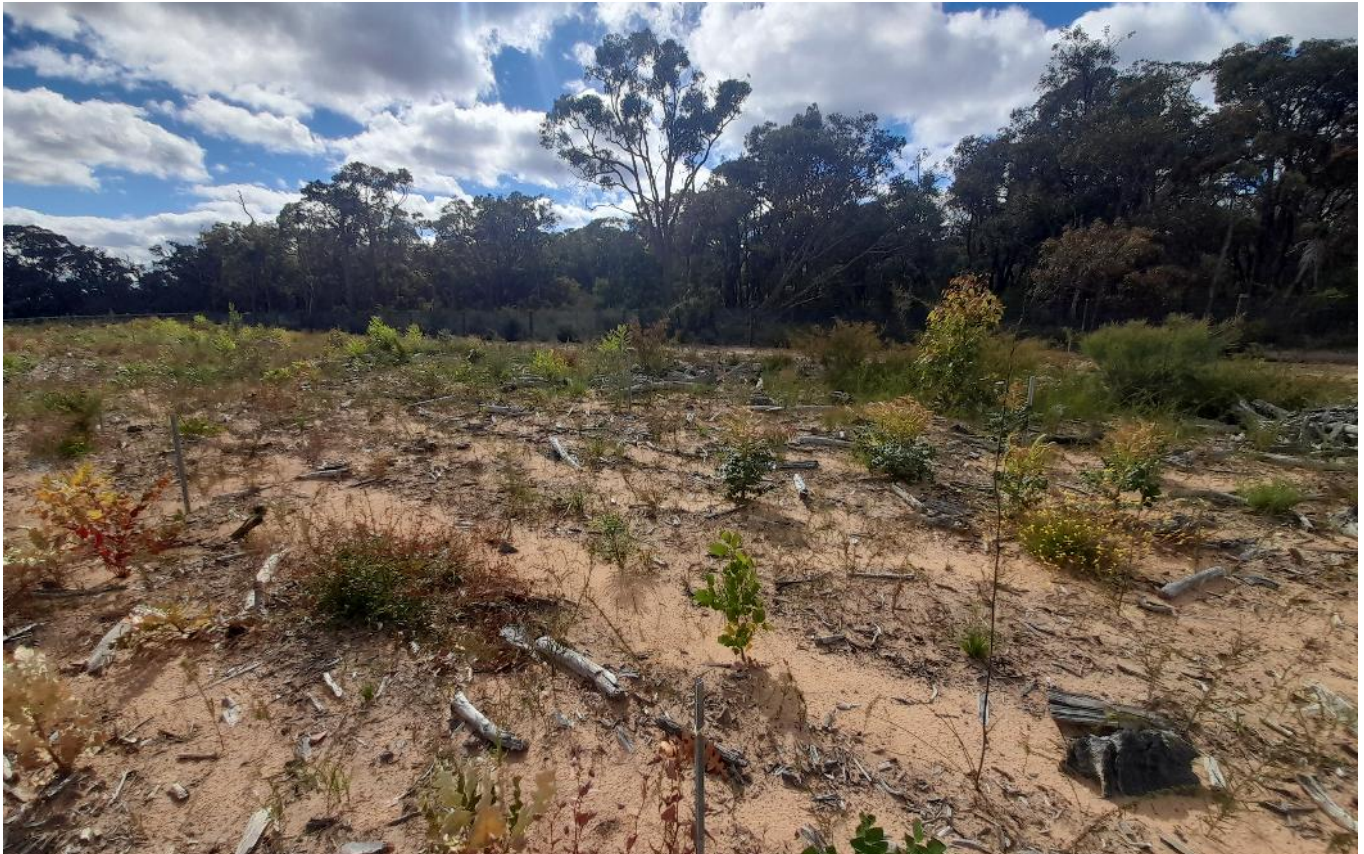
Figure 7: Quadrat 1 Photo - Most Recent Late Spring Monitoring Event November 28th 2022
