APPENDIX A: DARDANUP MINE ACID SULPHATE SOILS MANAGEMENT PLAN

ACID SULFATE SOILS MANAGEMENT PLAN BUREKUP MINERAL SANDS DEPOSIT

DMS-EMP-10.2

Report Date: 14 March 2011

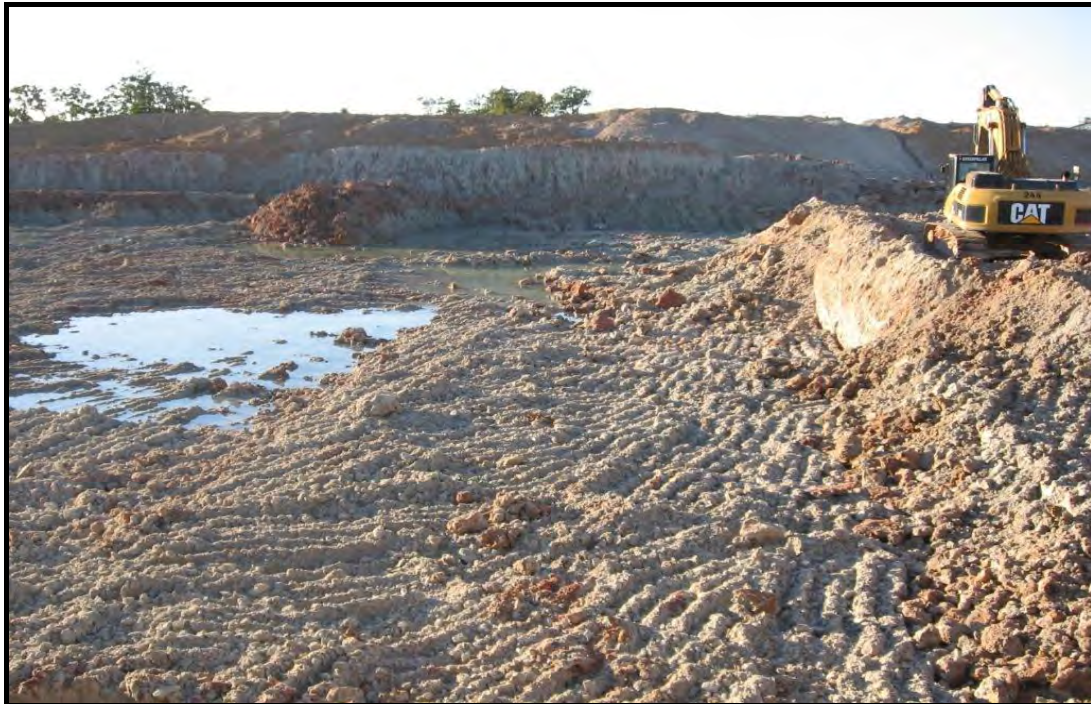
Plate 1: Control of Groundwater by Mining the Deepest Horizon first, then Moving up Slope

Drainage channels will be established around the perimeter of each pit allowing the dry mining techniques to be employed and diverted groundwater to re-infiltrate the superficial aquifer (Plate 2). These drainage channels will aid in reducing the effective radius of influence, defined as an air exchange distance from the geological window (i.e. the pit) that a given percentage of the atmospheric oxygen content reaches during a certain period with high atmospheric pressure (Elberling *et al.*, 1998).

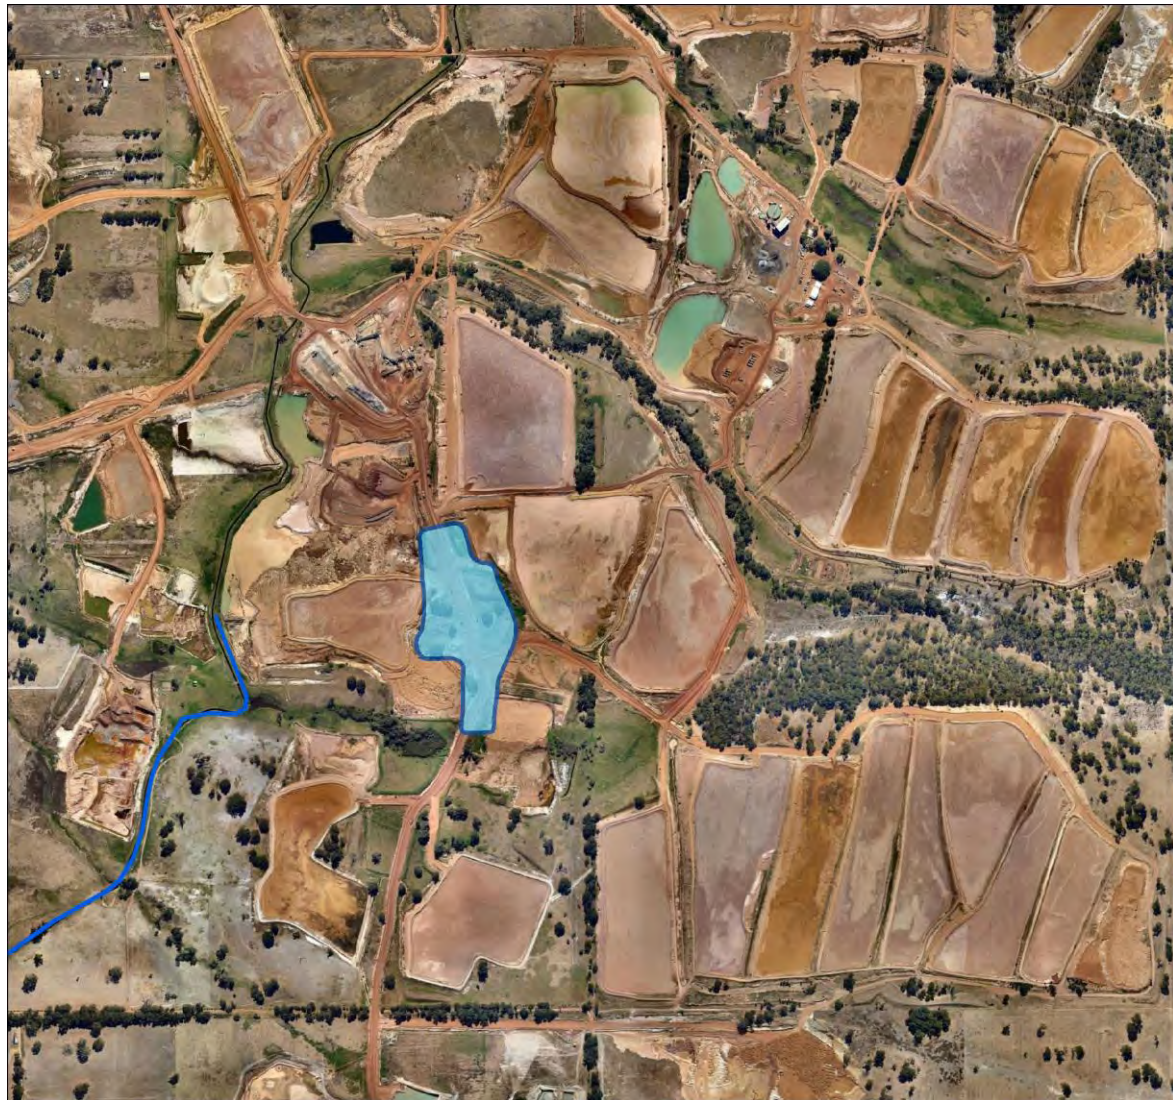
Figure 1: Proposed T5 Pit Lake

The excavation of the pit lake to an invert level of 36 mAHD intersects the local water table, and results in a permanent body of water. The free surface of the lake will be subject to evaporation all year, with evaporative losses a function of the season and the area of the lake's free surface. Based on annual evaporation of 1600 mm/annum (BoM), a pan correction factor of 0.80 and an average surface area of 49,000 m² indicate average daily evaporation loss of 170 m³/day.

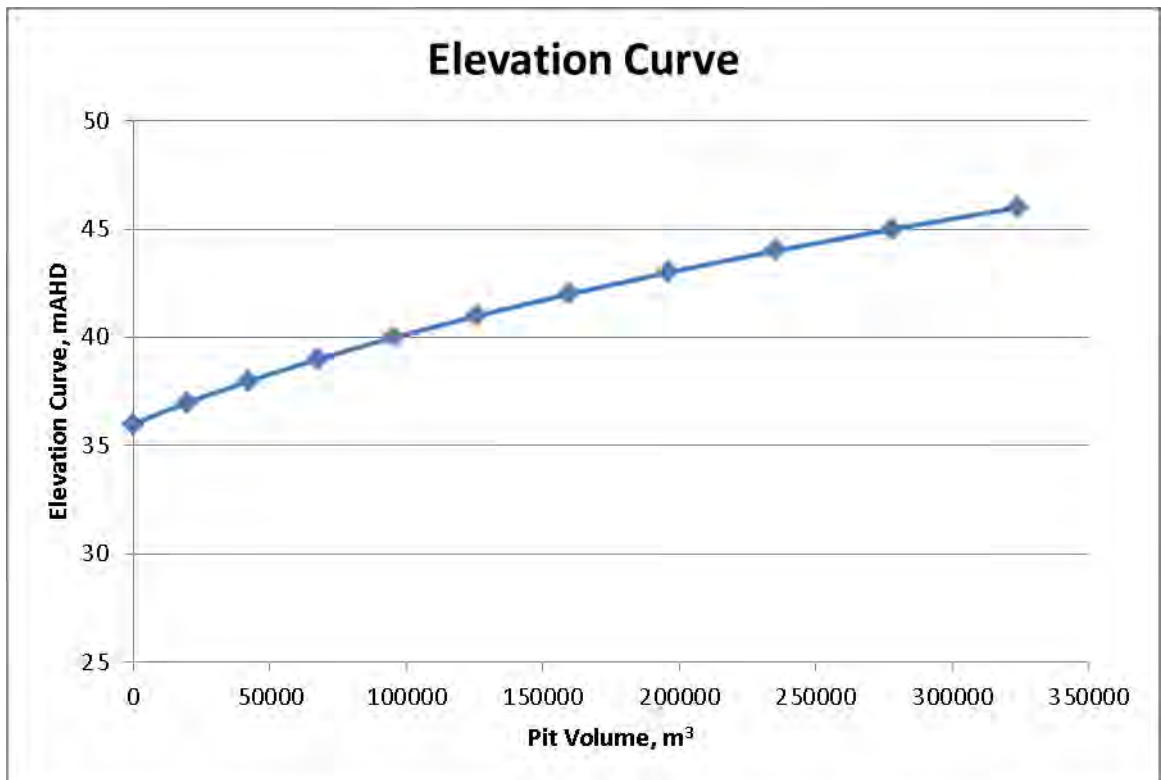
Figure 2: Pit Void Area and Fill Curve

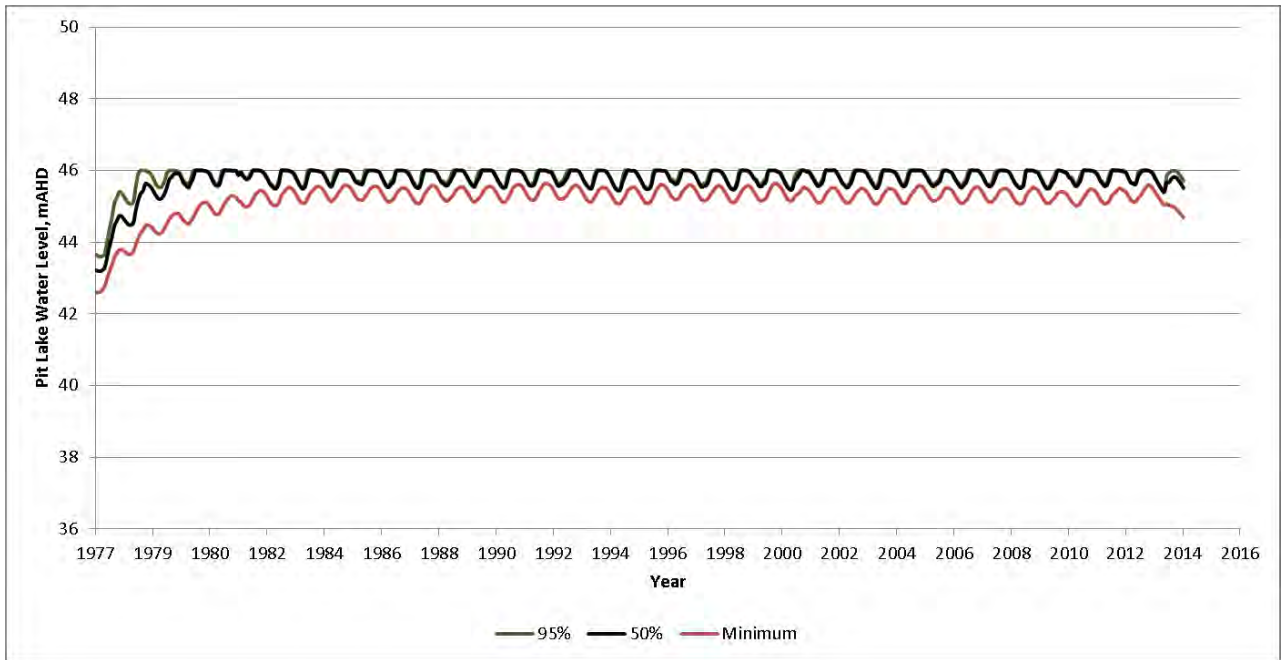
Figure 5: Pit Lake Water Level - Dry Rainfall Conditions

The results for the wet rainfall sequence are consistent with the model, with the pit lake water level being stable at approximately 46 mAHD, while pit lake discharge increases to reflect increased rainfall.

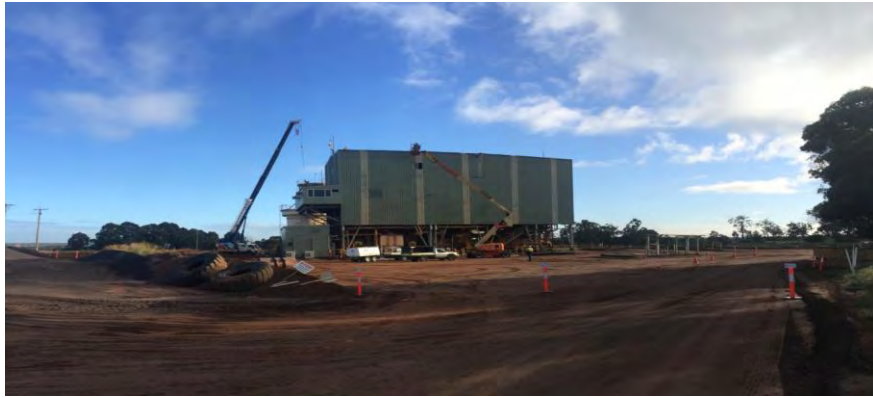
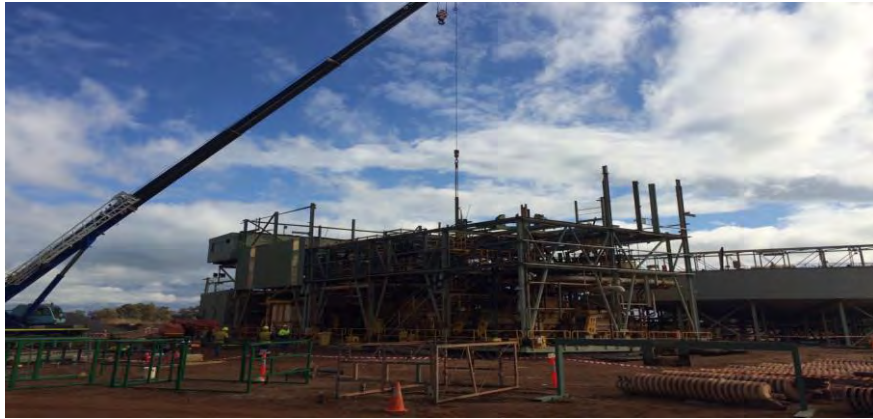
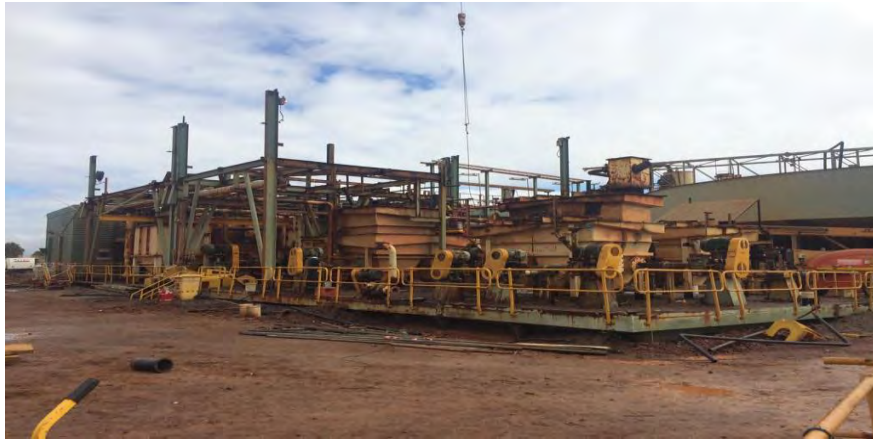
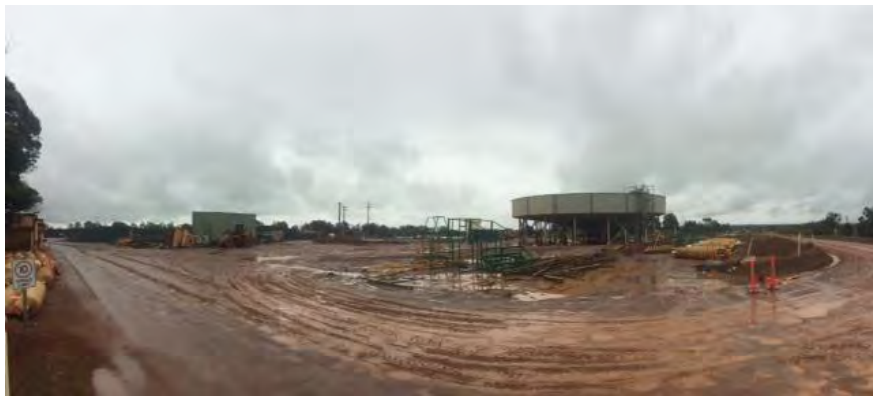
The wet concentrator and associated plant was under de-construction from Q2 of 2016 as shown in the photos below and as at October 2016 only the thickener remains and is presently commencing de-construction. The deconstructed plant and equipment has been relocated to a designed temporary laydown area or taken off site for refurbishment prior to being relocated to the proposed Yoongarillup Mine in 2017.

The feed prep plant was de-constructed During Q1 and Q2 of 2016 with the dismantled plant either taken to a designed temporary laydown area for repairs, taken offsite for refurbishment, or recycled through scrap metal dealer. The feed prep plant and equipment shall remain at the laydown area until relocation to the proposed Yoongarillup Mine in 2017.
