APPENDIX 1

GROUNDWATER DEPENDENT ECOSYSTEM PERFORMANCE REPORT

**2023 GROUNDWATER DEPENDENT ECOSYSTEMS
PERFORMANCE REPORT
YALYALUP MINERAL SANDS PROJECT**

Ministerial Statement 1168

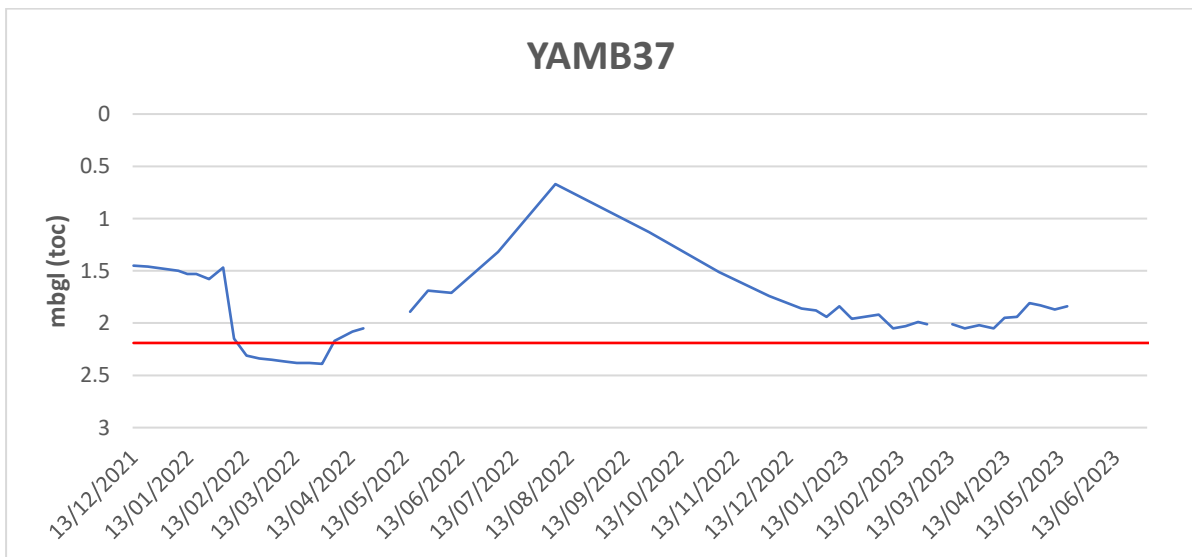
Figure 7 - YAMB 37 Groundwater Levels

YAMB 37 is a monitoring bore alongside the planted community of *Verticordia plumosa* on the Princefield Rd reserve. Doral committed to monitoring these individuals as they are listed as endangered by both DBCA and under the EPBC Act. They are not on the McGibbon track so are not located within the supplementation zone. Levels did not reach the trigger level of 1.87mbgl during the reporting period. Dewatering activities were conducted approximately 1km southwest of the monitoring bore. See Figure 7.

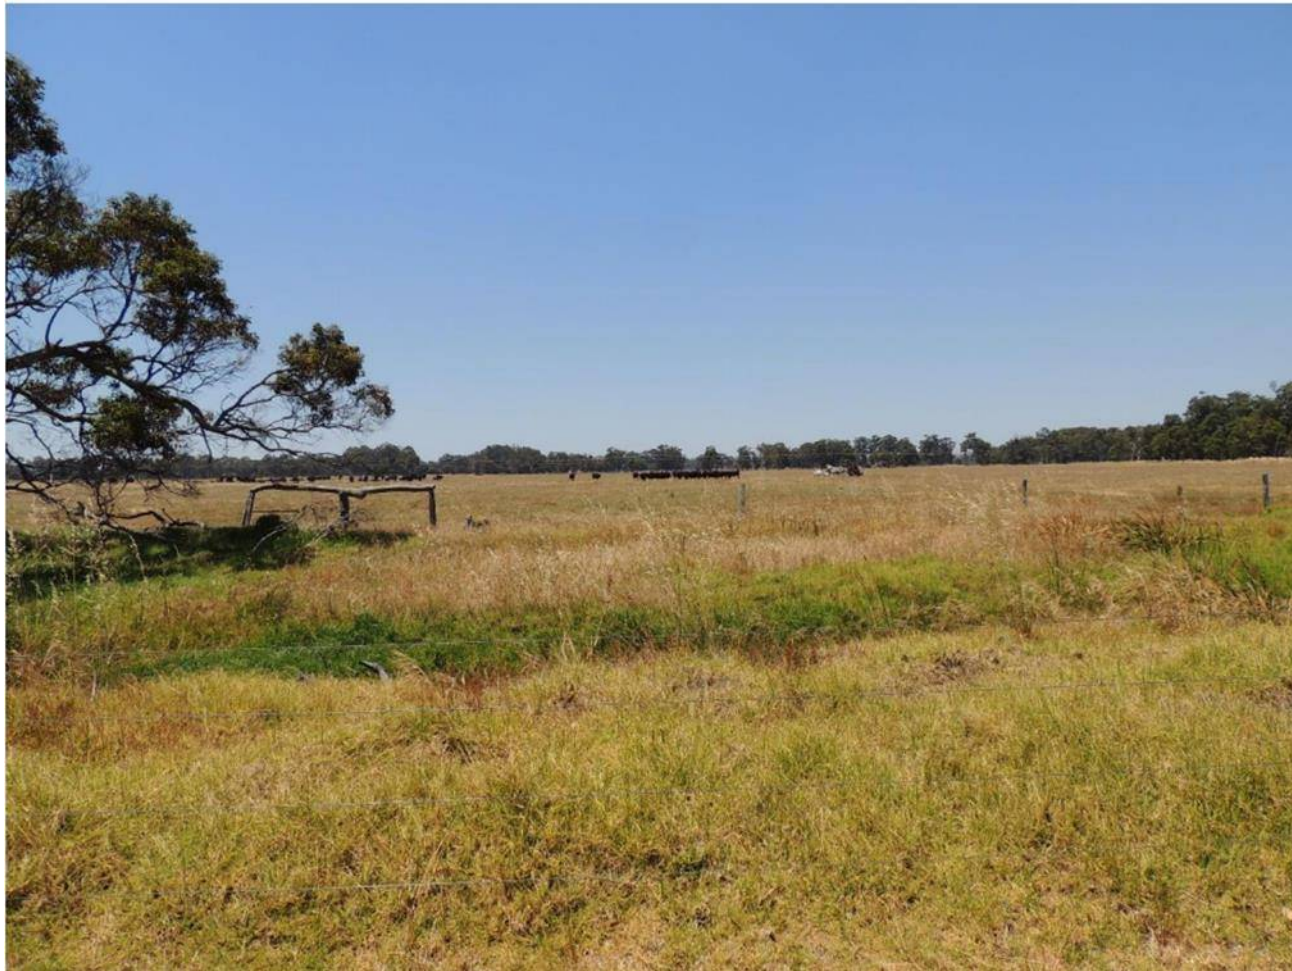
Figure 1: Abba River prior to bridge installation

17354	Abba River	Minimal impact - Doral's approach was to undertake flood studies and install a temporary bridge which spanned beyond the river extent so as to not impede flow and did not require disturbing the river beds or banks. Scour protection was installed over the river bank to ensure erosion reduction. The location of the bridge was chosen due to lack of native vegetation, therefore further reducing impact to the river	Nil

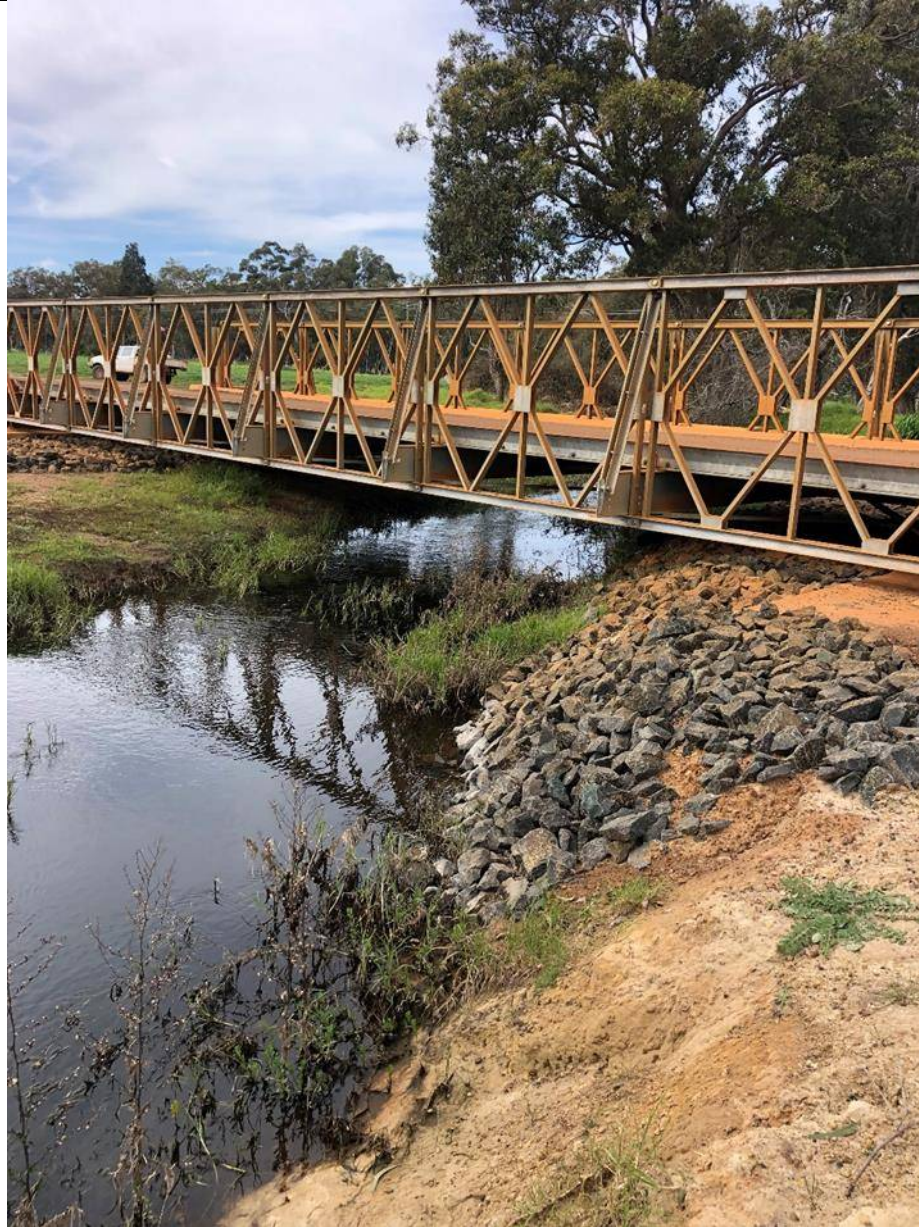
Figure 2: Abba River post bridge installation with rock pitching

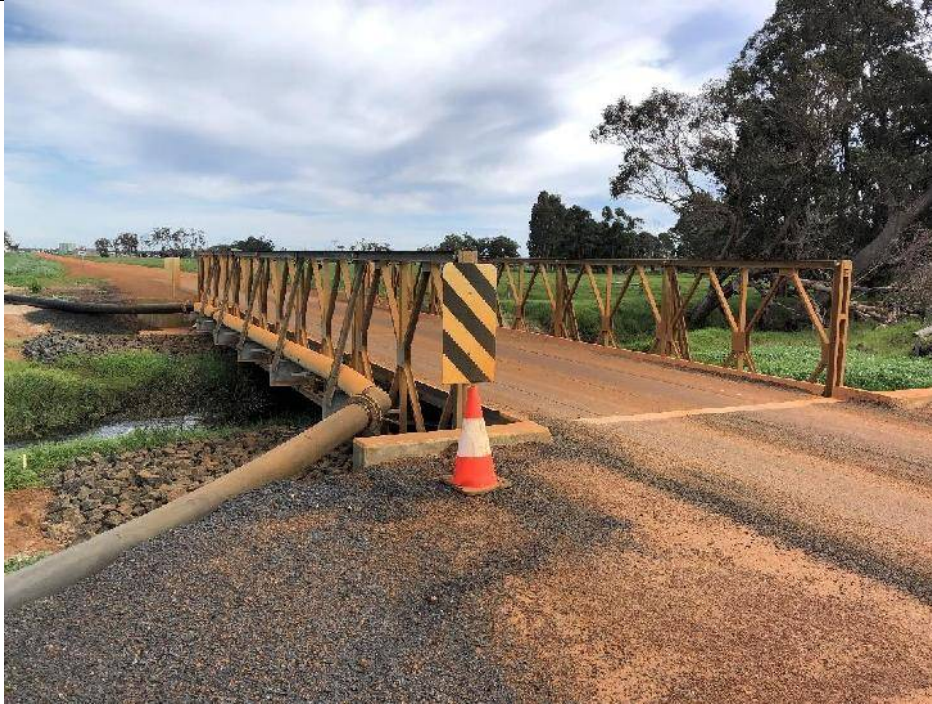
Figure 3: 23m of bitument installed either side of bridge
